Cultural Landscape Analysis of Existing Historic Districts

Picatinny Arsenal, New Jersey

Final report

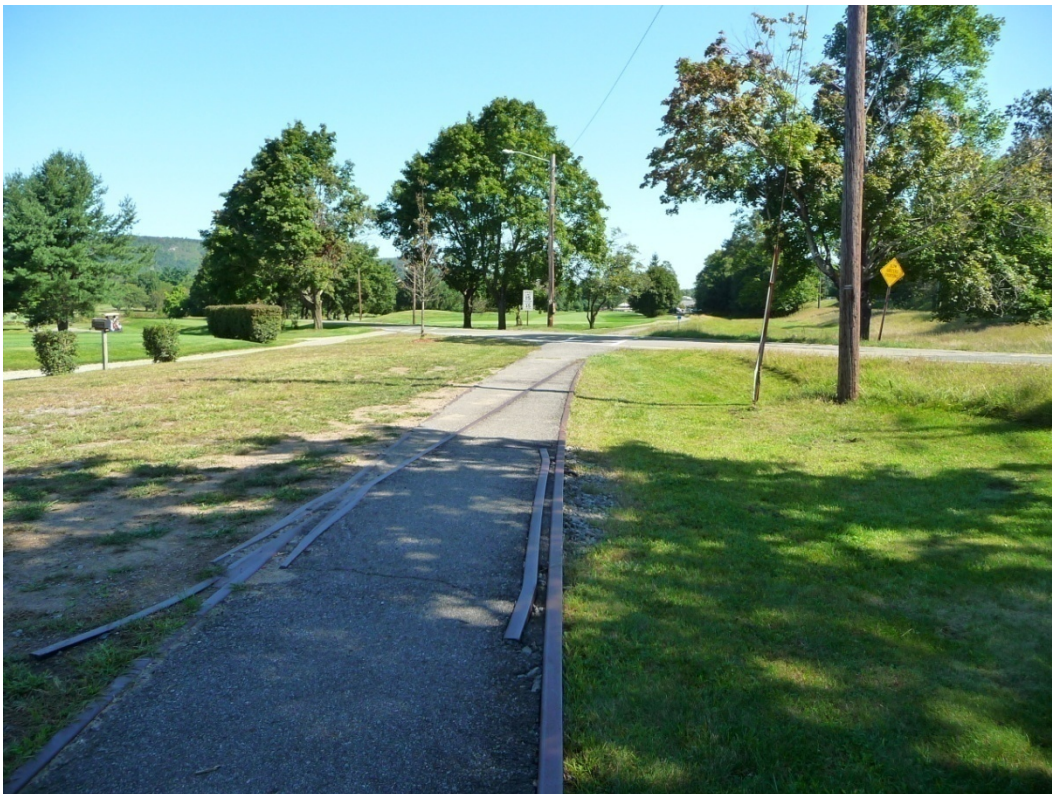
Figure 41. Looking eastward near the intersection of 1st Street and Parker Road at the modified railroad track, now used as a walking path (ERDC-CERL, 2012).

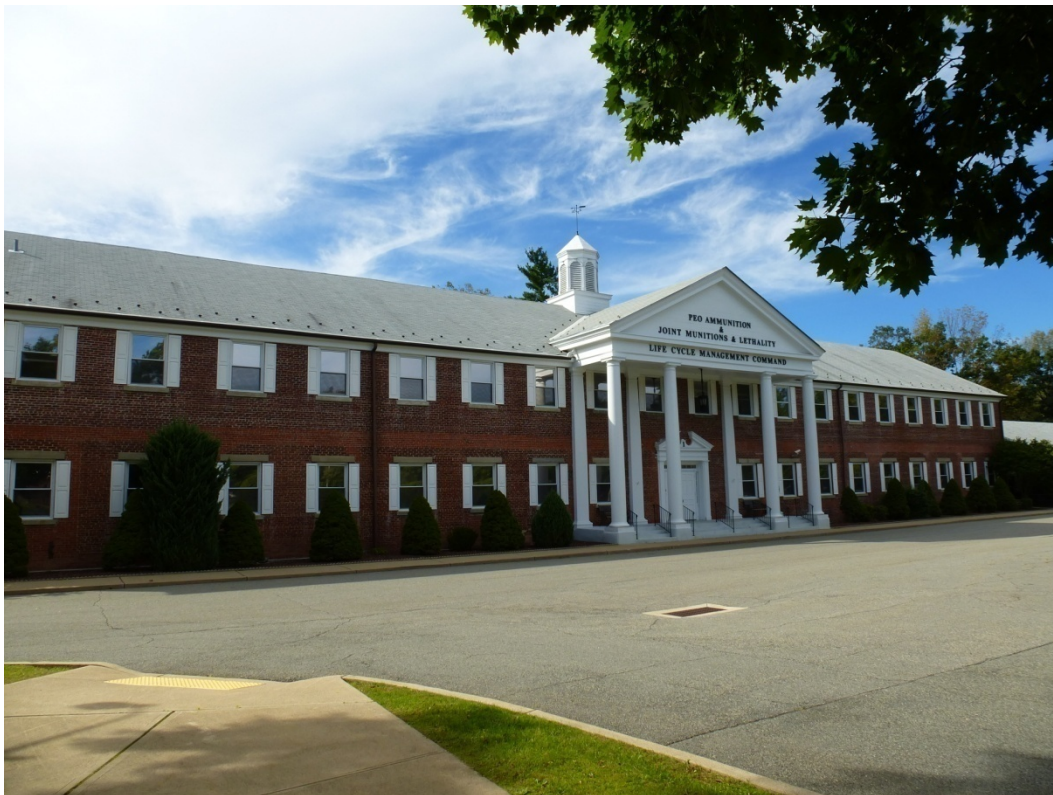
The current Building 1 (formerly Building 171) is an extremely large, long, two-story brick structure that presents a relatively flat facade broken in the center by a front pediment, two-story porch supported by Doric columns (Figure 50). The long line of the roof is broken by a hexagonal cupola that sports a weather vane. The window features concrete sills and pediments and are surrounded by decorative shutters. While the start date of the building's construction is uncertain, a blueprint detailing the structure's front door shows that this building was in existence by June 18, 1940. Portions of the exterior of the building are remnants of Magazine No. 2, which was built circa 1885. The building is approached off Buffington Road through an oval driveway system.⁴⁹

Figure 50. Building 1, Administration Building/Post Headquarters (ERDC-CERL 2012).

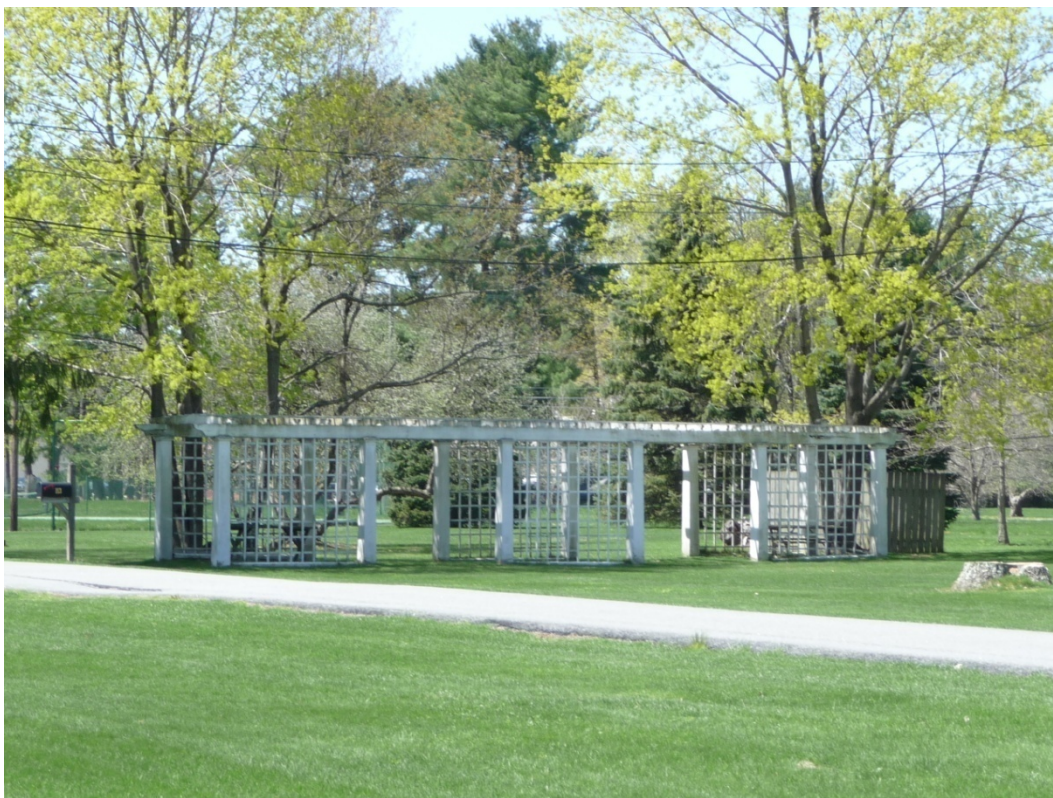
Building 113A is located north of the Assistant Officers' Quarter (Building 113) and is similar to the pergola near Building 112. It is possible that this pergola was constructed in the 1930s at the same time that pergola 112A was replaced. The pergola has six pairs of tapered square wood piers that rest directly on the ground. The tops of the piers feature simple square capitals. Two bays are open, while three bays have wood lattice between the piers (Figure 56). The piers support double-board beams that are bolted together along the length of the structure. The beams support raters with decorative ends.⁵⁵ This structure was demolished in 2015 with SHPO consultation. Mitigation included completed architectural drawings so structure could be rebuilt in future depending on funding.

Figure 56. Building 113A (ERDC-CERL, 2013).

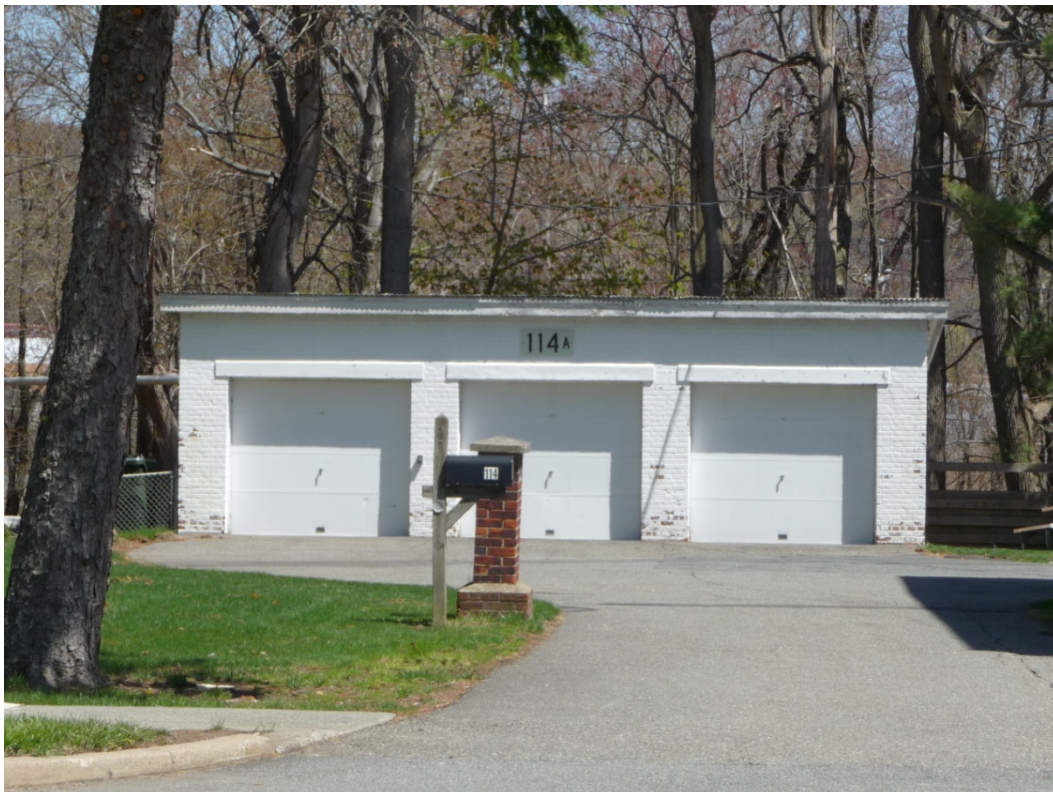
Building 114A is a small, one-story, three-door garage for Building 114. It sits on a concrete foundation and has galvanized iron on a wood roof (Figure 58). The garage was built in 1937 in connection with other improvements to Building 114.⁵⁷

Figure 58. Southwest elevation of Building 114A (ERDC-CERL, 2013).

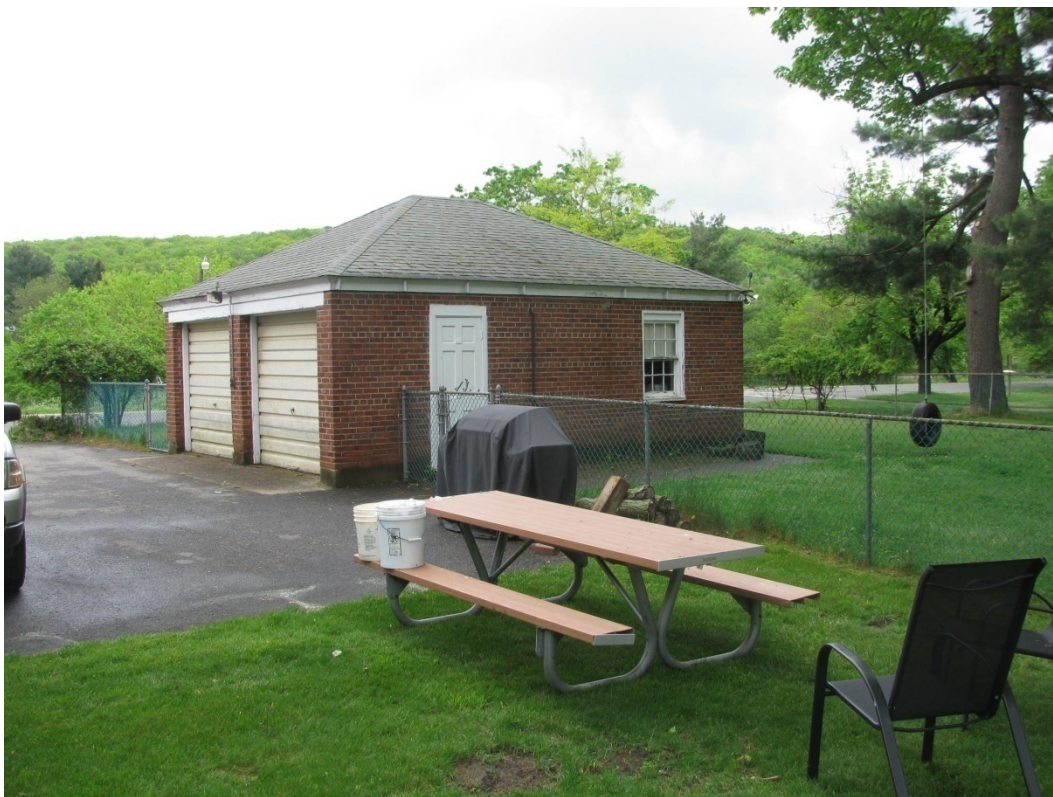
Building 115A is a one-story, rectangular, gable roof, two-car garage (Figure 60) situated near Building 115. It was built in 1943 as a garage and is still used as such. It has a number of Colonial Revival style features including a hipped roof, common bond brick construction, and 6/6 double-hung windows (vinyl replacement windows per SHPO consultation). The building has wood sills, wood lintels, and two new aluminum roll-up garage doors on the north side.⁵⁹

Figure 60. Northwest oblique of Building 115A (PICA Cultural Resources Office).

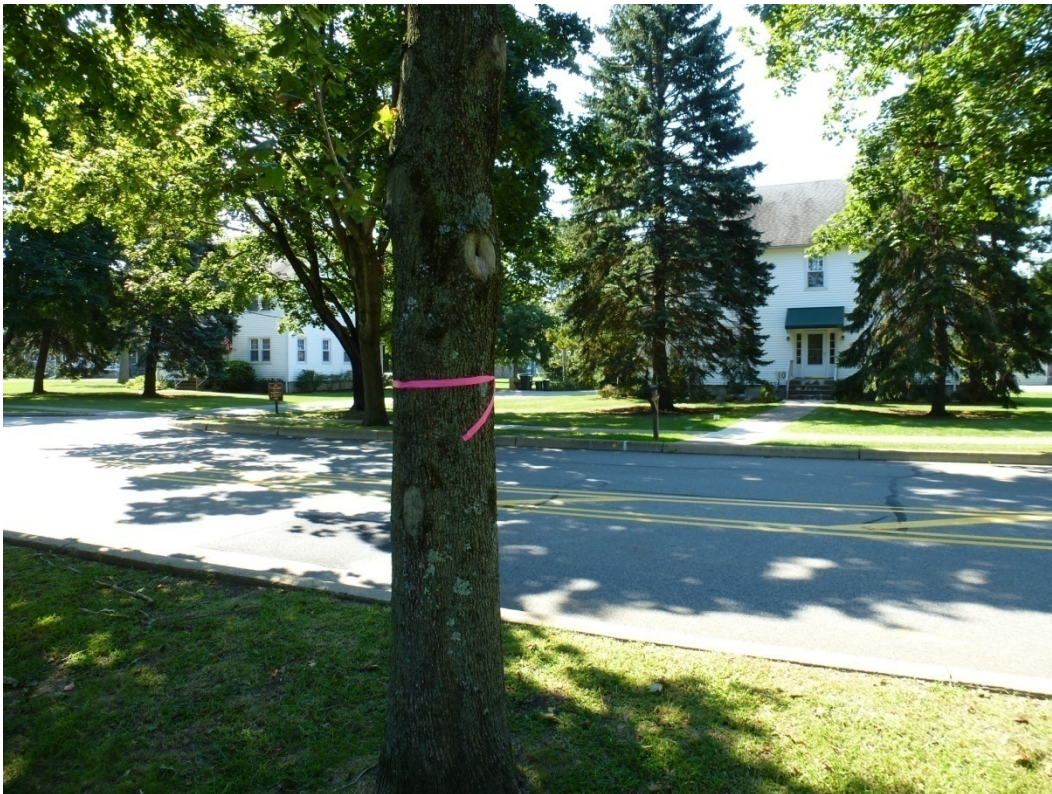
Figure 145. A tree located along Farley Avenue that is tagged for removal should be replaced with a native oak tree (ERDC-CERL, 2012).

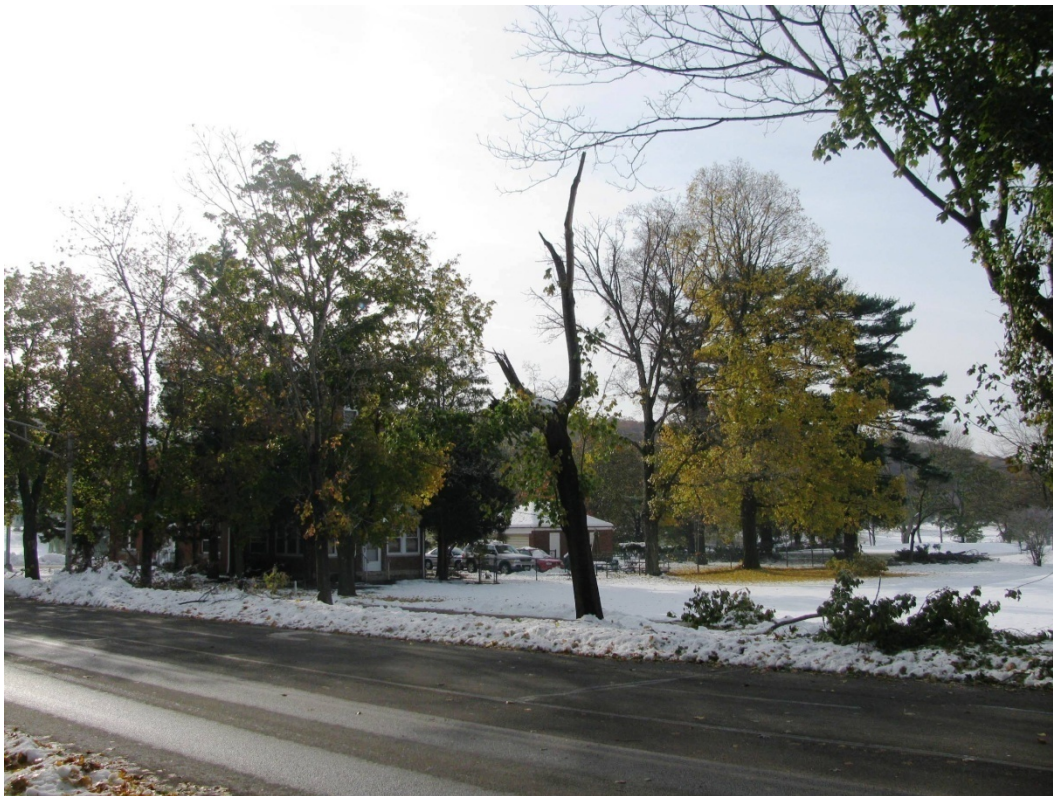
Figure 146. An example of a damaged or dead tree in the historic district that should be replaced (PICA Cultural Resources Office).

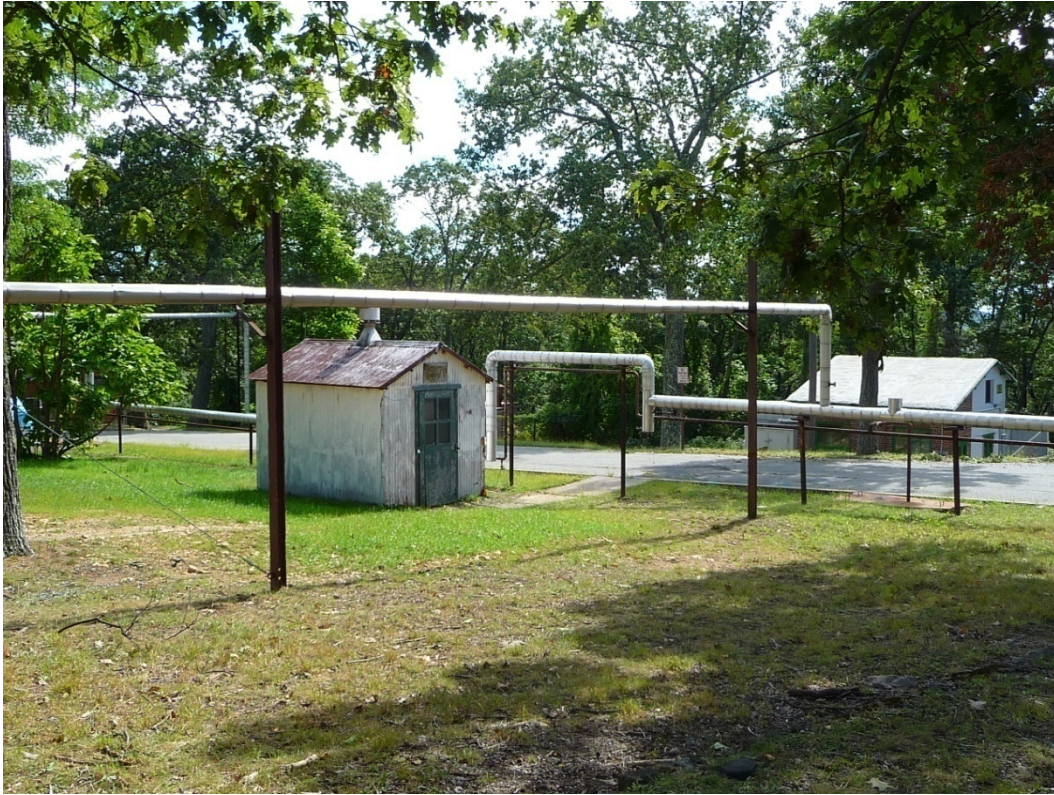
Figure 208. Steam lines located throughout the 600 Test Area (ERDC-CERL, 2012).

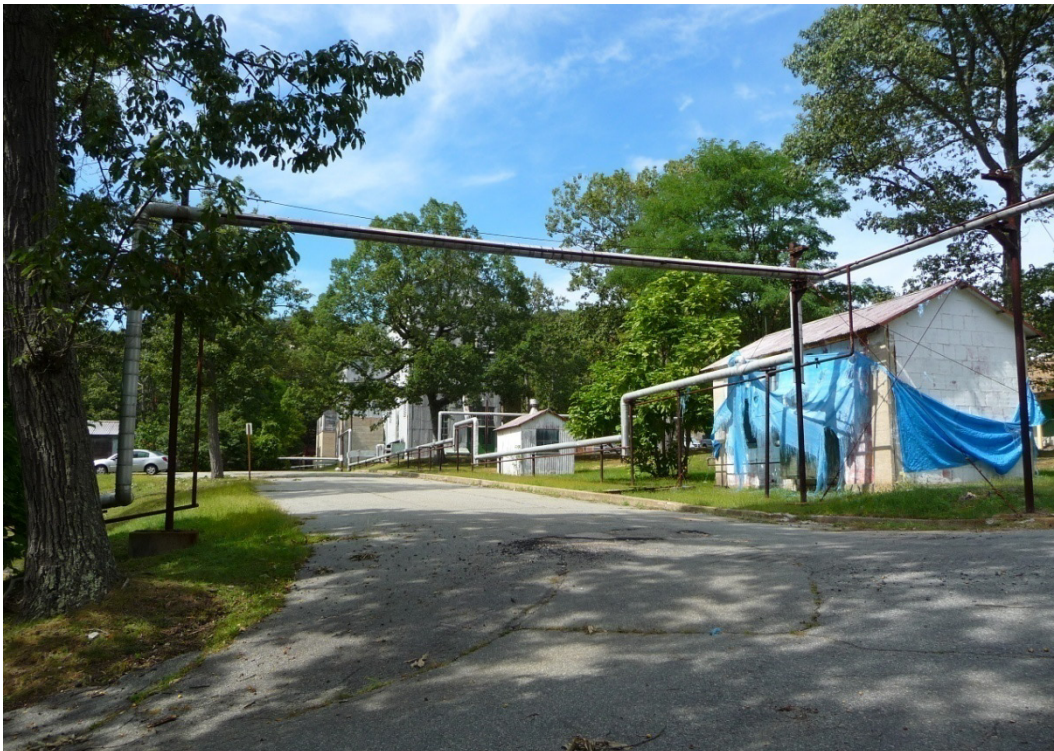
Figure 209. Replacement steam lines placed high above the paved roads in the 600 Test Area (ERDC-CERL, 2012).

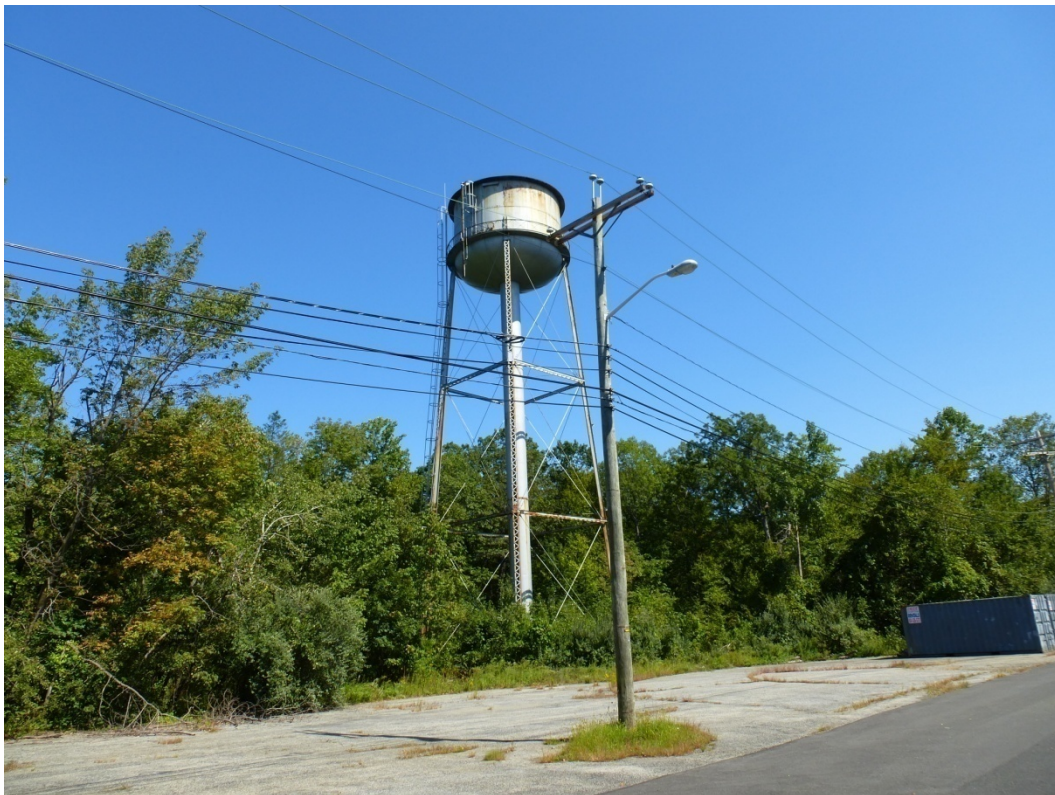
Figure 236. Current condition of the water tower, Building 1500 (ERDC-CERL, 2012).

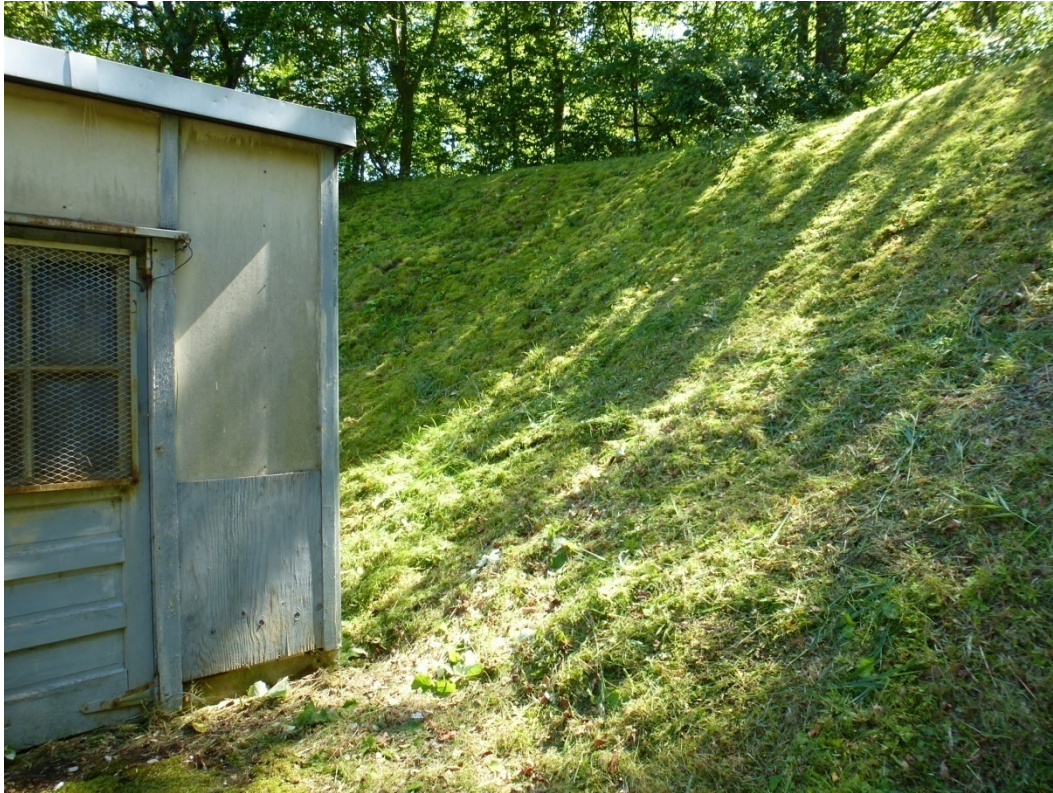
Figure 274. Relationship of building and earth barricade (ERDC-CERL, 2012).
